ATLANTIC COAST BASIN  
JUMPING BROOK  
MONMOUTH COUNTY  
NEW JERSEY

# JUMPING BROOK DAM

## NJ00084

PHASE 1 INSPECTION REPORT  
NATIONAL DAM SAFETY PROGRAM

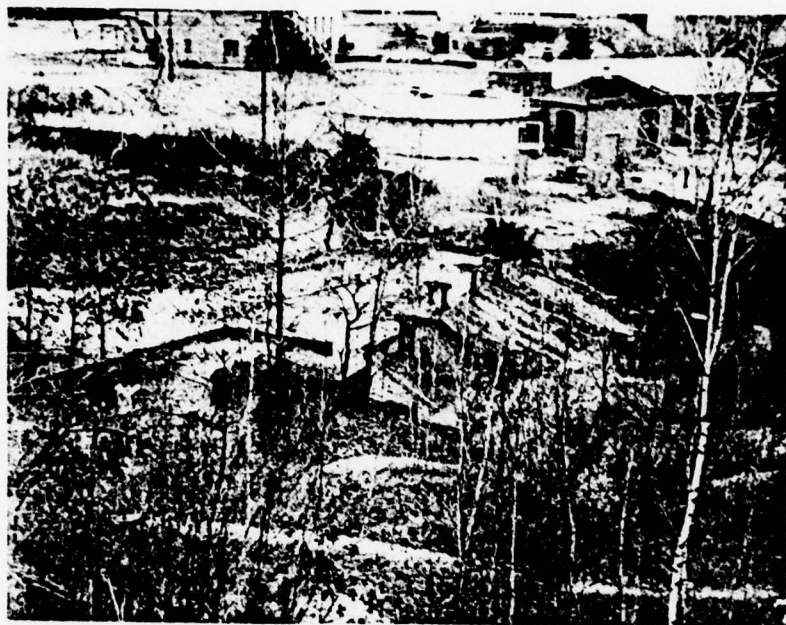
Dam Overview

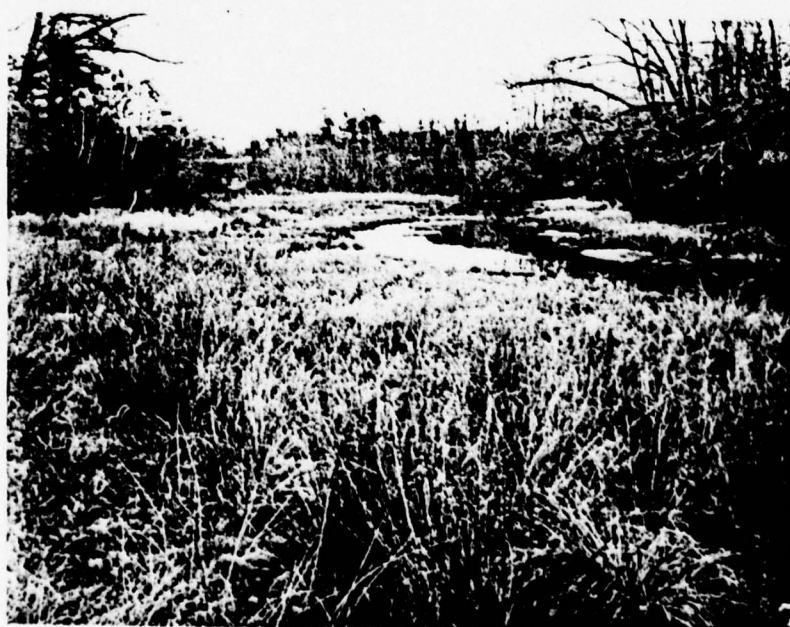
Upstream Reservoir

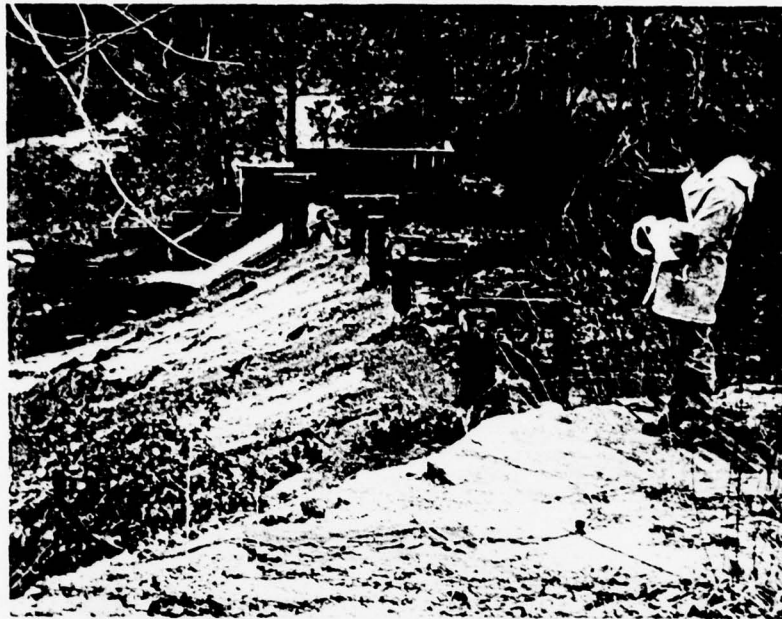
The timber spillway is in fairly good condition, especially when considering the age of the older 29-foot section on the west end. The vertical bulkhead is in good alignment and there are no apparent structure failures. About 35 feet upstream from the left abutment there is a concrete headwall and water supply intake which feeds a 16-inch cast iron main that extends to a downstream settling basin and coagulation tank. The inspection catwalk over the spillway has been demolished, but its supporting piers remain in usable condition. The right end of the spillway is at a slightly (1" to 2") lower elevation than the left end and carries the low water overflow. The plank and riprap backslopes are on 6V:12H and 3V:12H slopes respectively. They are also in satisfactory condition. The plans indicate the existence of a 16" blow-off line centered under the older spillway section, but its inverts could not be observed and it is apparently now blocked up. Water Company engineers were not sure if this line exists, but if so, it is unusable in its present buried condition.

Spillway (Looking South)

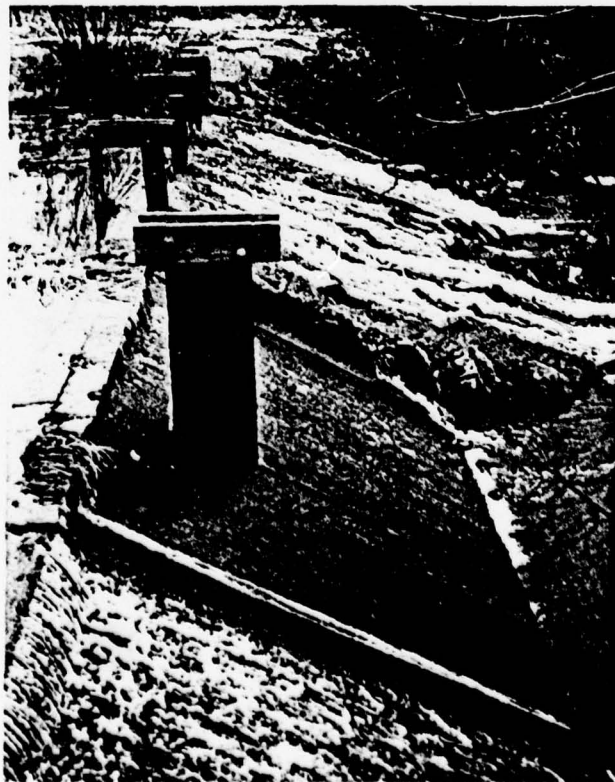
Inspection Wall Supports

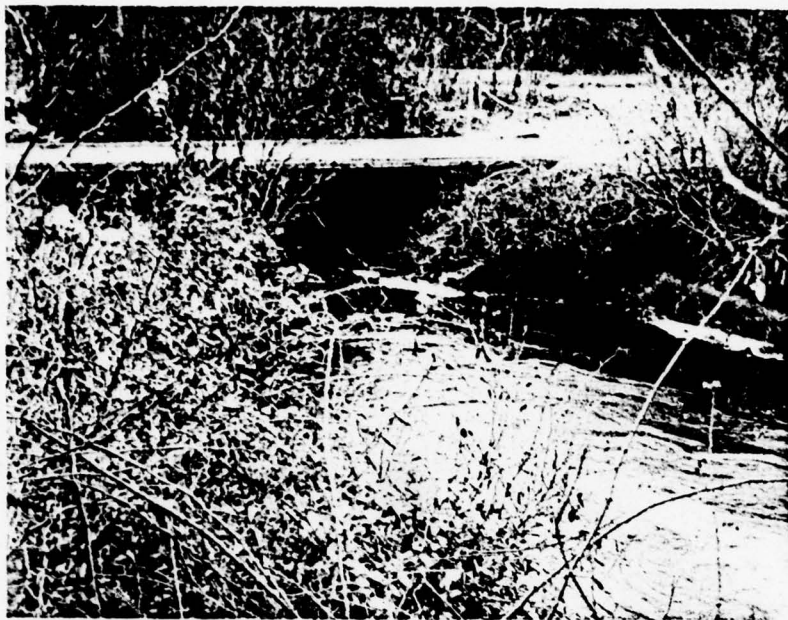
Downstream Channel

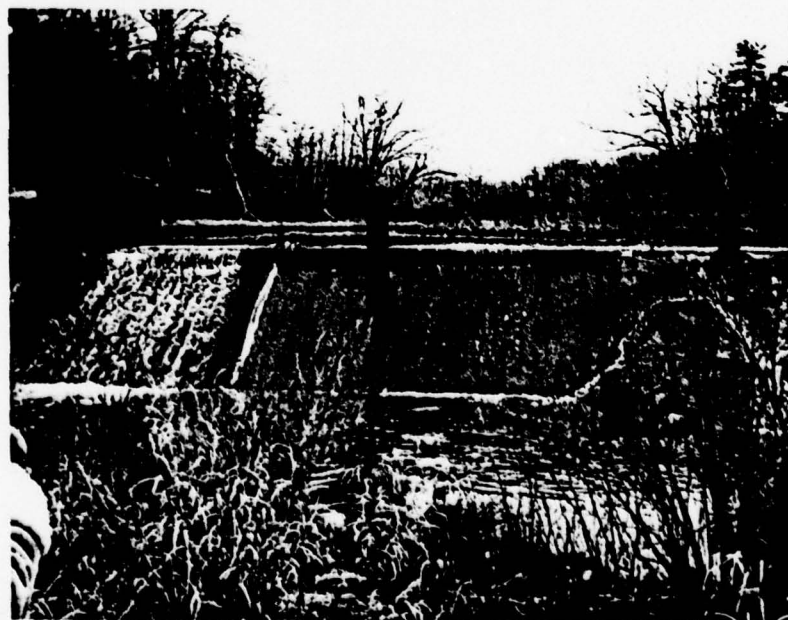
VISUAL EXAMINATION OF	OBSERVATIONS	REMARKS OR RECOMMENDATIONS
JUNCTION OF EMBANKMENT AND ABUTMENT, SPILLWAY AND DAM	Minor erosion and seepage at right abutment.	
ANY NOTICEABLE SEEPAGE	Seepage at right abutment.	
STAFF GAGE AND RECORDER	U.S.G.S. Gage Station Neptune City No. 4077.6	
DRAINS	No embankment drains. Drop inlet to plant (see page 6).

Right End of Spillway
